# LYNG CHURCH

Fredericia, Denmark

Roof: 2000 m<sup>2</sup> 15 t Double Standing Seam  
RHEINZINK-prePATINA blue-grey

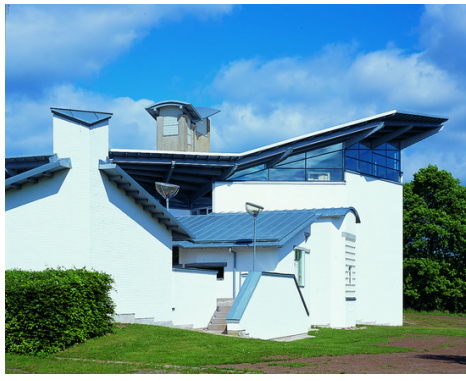
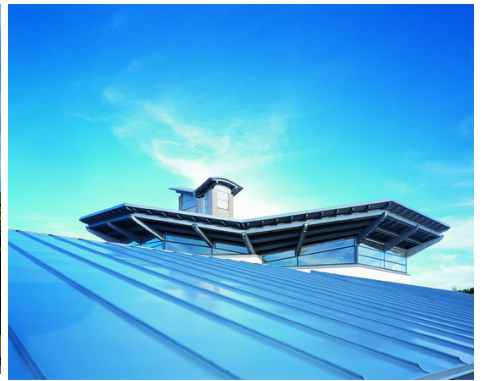
A new zinc cladding in the surface RHEINZINK prePATINA was mounted everywhere at an underlayer of 15 mm high, perforated zinc hat profiles due to extensive rot damage in roof ridges and roof edges. All rotten wood was replaced and painted before the zinc cladding was mounted. By mounting the perforated profiles, an 18 mm. ventilated cavity was ensured between the zinc cladding and the existing wooden structures.

To achieve an optimal airflow, the cladding on the back of all main girders, roof trusses and rafters is made of perforated zinc. The zinc overhang cladding is made with an air gap at all edges - also in perforated zinc. Perforation with a hole diameter of 3 mm. was chosen, as this hole size ensures that bees and other insects are not able to enter the ventilated cavities.
